Manhole Inspection Summary

Manhole # S21A__042MH

Insp Date: **9/14/07 10:04 AM**

Location Address: **725 MOUNT ST**

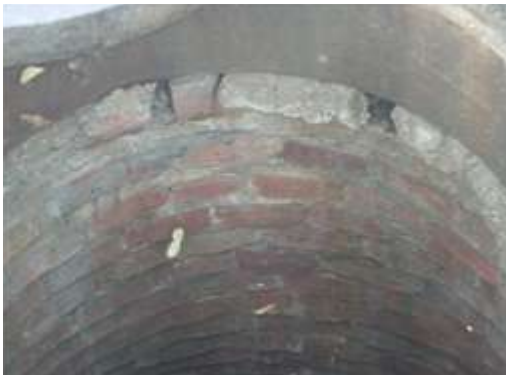
Defect 3

Condition: ☐ Sound ☐ Cracked ☐ Root Intrusion ☒ Loose Brick ☒ Deteriorated

LOOSE CHIMNEY BICKS

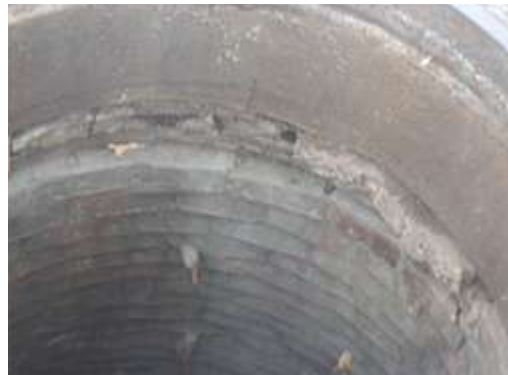
Defect 2

DETERIORATED CHIMNEY

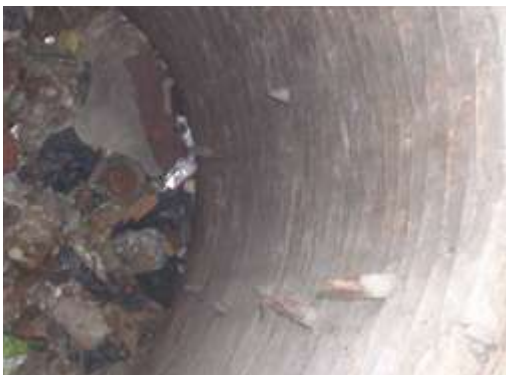
Defect 1

Steps Count: **0** Missing: **5** ☐ Corroded

MISSING STEPS

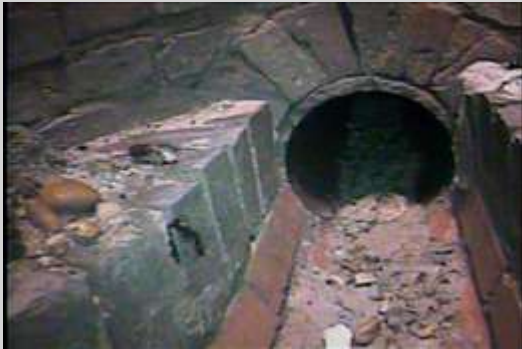
12 O'Clock Outflow

Pipe Height: **8.4** (in.) Rod and Bar (Angled)
Pipe Material: **Clay** ☐ Pipe Lined
Invert Depth: **9.31** (ft.) Flow Characteristics: **Slow**
Deposits: ☐ None ☐ Mud ☐ Sludge ☒ **Debris** ☐ Grease
Silt Depth: **2** (in.) Deposits Extent: **Light**
Infiltration: **None** Pipe Seal Cond: **Sound**

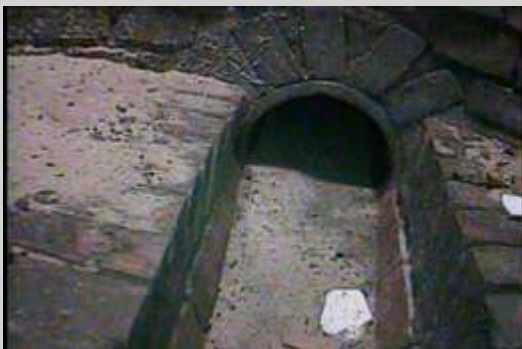
6 O'Clock Inflow

Pipe Height: **7.2** (in.) Rod and Bar (Angled)
Pipe Material: **Clay** ☐ Pipe Lined
Invert Depth: **9.20** (ft.) Flow Characteristics: **None**
Deposits: ☐ None ☒ **Mud** ☐ Sludge ☐ Debris ☐ Grease
Silt Depth: **2** (in.) Deposits Extent: **Light**
Infiltration: **None** Pipe Seal Cond: **Sound**

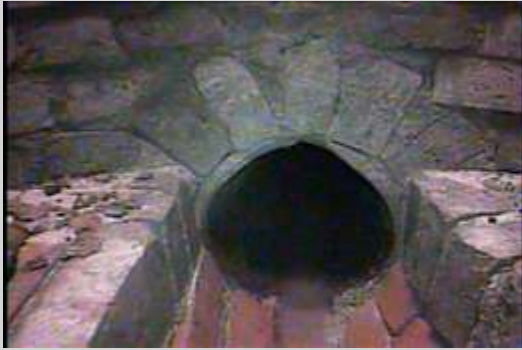
9 O'Clock Inflow

Infiltration: **None** Pipe Seal Cond: **Broken**
